DEPARTMENT OF TRANSPORTATION

Quality Assurance and Source Inspection

Contract #: 04-0120F4Cty: SF/ALA Rte: 80 PM: 13.2/13.9File #: 69.28**WELDING INSPECTION REPORT****Resident Engineer:**Pursell, Gary**Address:** 333 Burma Road**City:** Oakland, CA 94607**Report No:** WIR-015160**Date Inspected:** 24-Jun-2010**Project Name:** SAS Superstructure**OSM Arrival Time:** 700**Prime Contractor:** American Bridge/Fluor Enterprises, a JV**OSM Departure Time:** 1900**Contractor:** Zhenhua Port Machinery Company, Ltd (ZPMC), Changxing Island **Location:** Shanghai, China**CWI Name:** Mr. Chen Xi / Mr.Li zhi jiang**CWI Present:** Yes No**Inspected CWI report:** Yes No N/A**Rod Oven in Use:** Yes No N/A**Electrode to specification:** Yes No N/A**Weld Procedures Followed:** Yes No N/A**Qualified Welders:** Yes No N/A**Verified Joint Fit-up:** Yes No N/A**Approved Drawings:** Yes No N/A**Approved WPS:** Yes No N/A**Delayed / Cancelled:** Yes No N/A**Bridge No:** 34-0006**Component:** Orthotropic Box Girder(OBG)**Summary of Items Observed:**

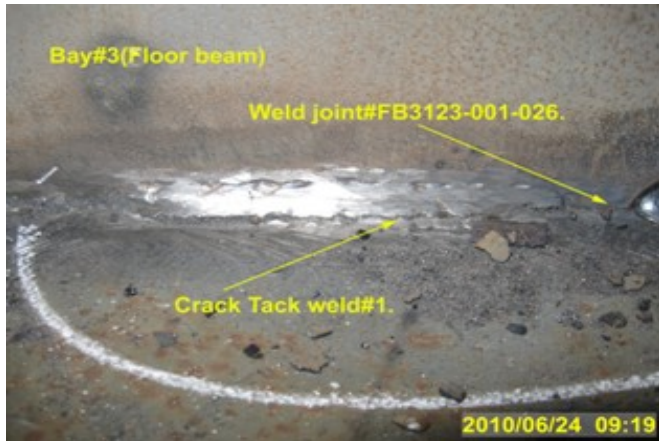
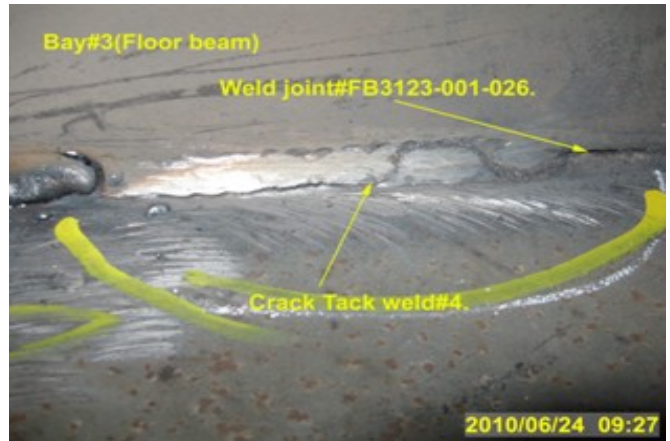
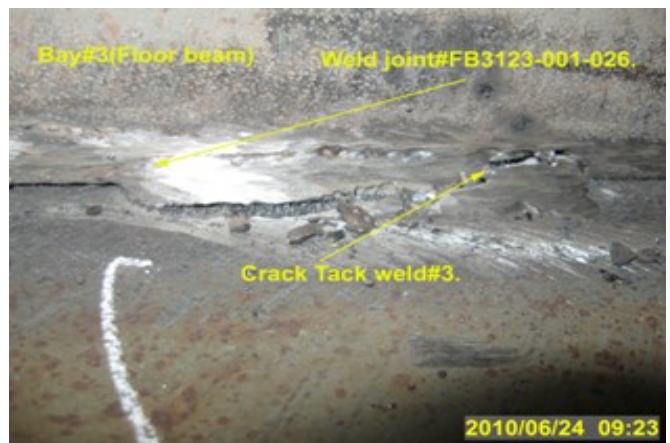
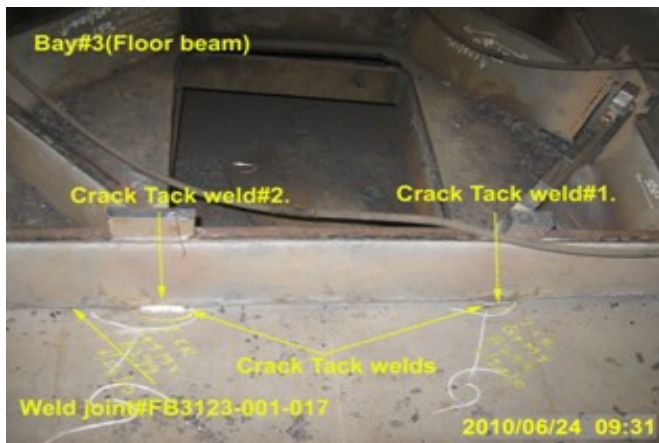
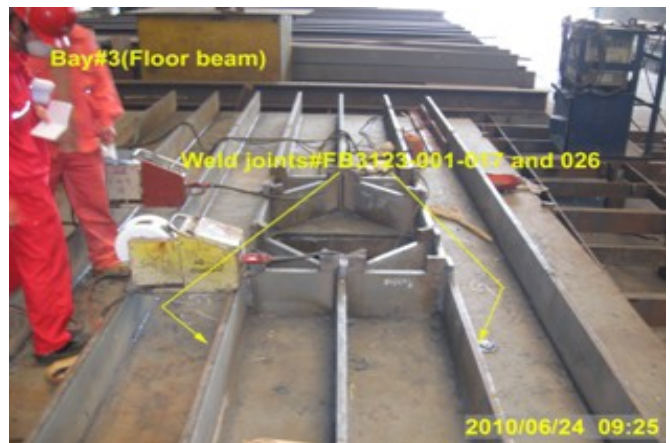
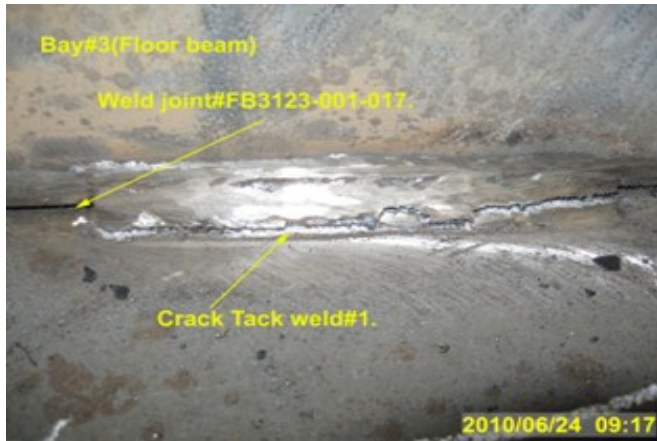
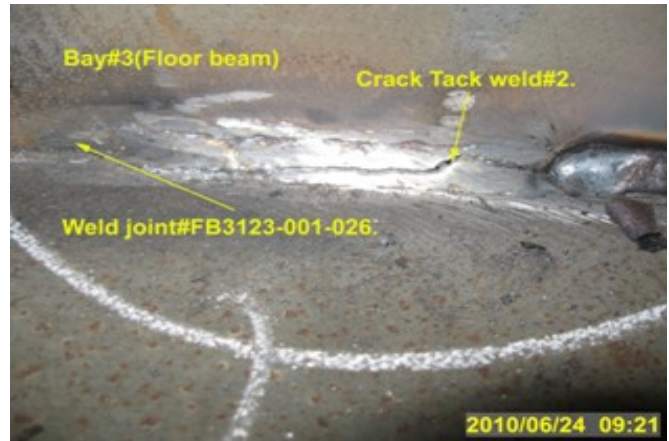
During random in process Visual Inspection this QA Inspector observed 2 (Two) and 4 (four) numbers of Crack tacks on Floor beam weld joint Numbers identified as: FB3123-001-017 and 026 respectively. The “Y” locations are for these defects measured to be approximately 1740, 2460 and 1600,1950,2560,3010 mm respectively from the nearest end of the weld joint. This QA informed to ZPMC Quality Control (QC) identified as Mr. Li zhi jiang and American Bridge/Fluor (AB/F) QA Inspector identified as Mr. Wang wen bin of the above issue, As per ZPMC QC and AB/F QA the Cracked Tack welds shall be removed by grinding and perform Magnetic Particle Testing (MT) for verifying no more defects prior to start the final welding.

Refer attached photos for additional details.
